CIVIL AERONAUTICS BOARD

AIRCRAFT ACCIDENT REPORT

NORTHWEST AIRLINES, INC.,
LOCKHEED ELECTRA, L-188C, N 137US,
O'HARE INTERNATIONAL AIRPORT
CHICAGO, ILLINOIS, SEPTEMBER 17, 1961

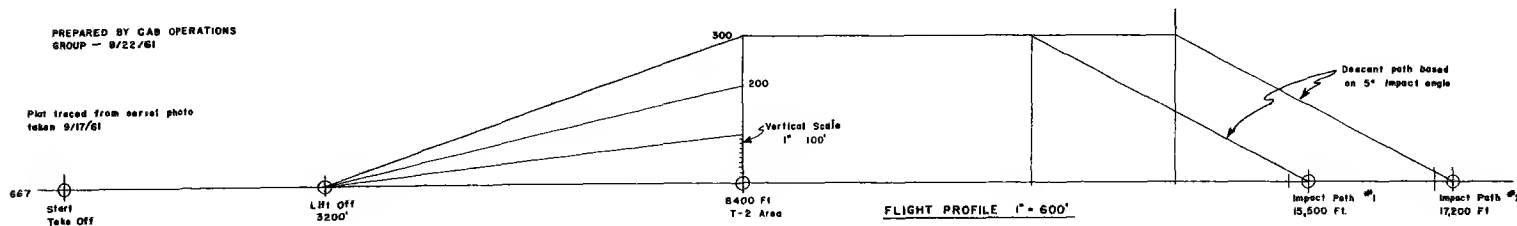
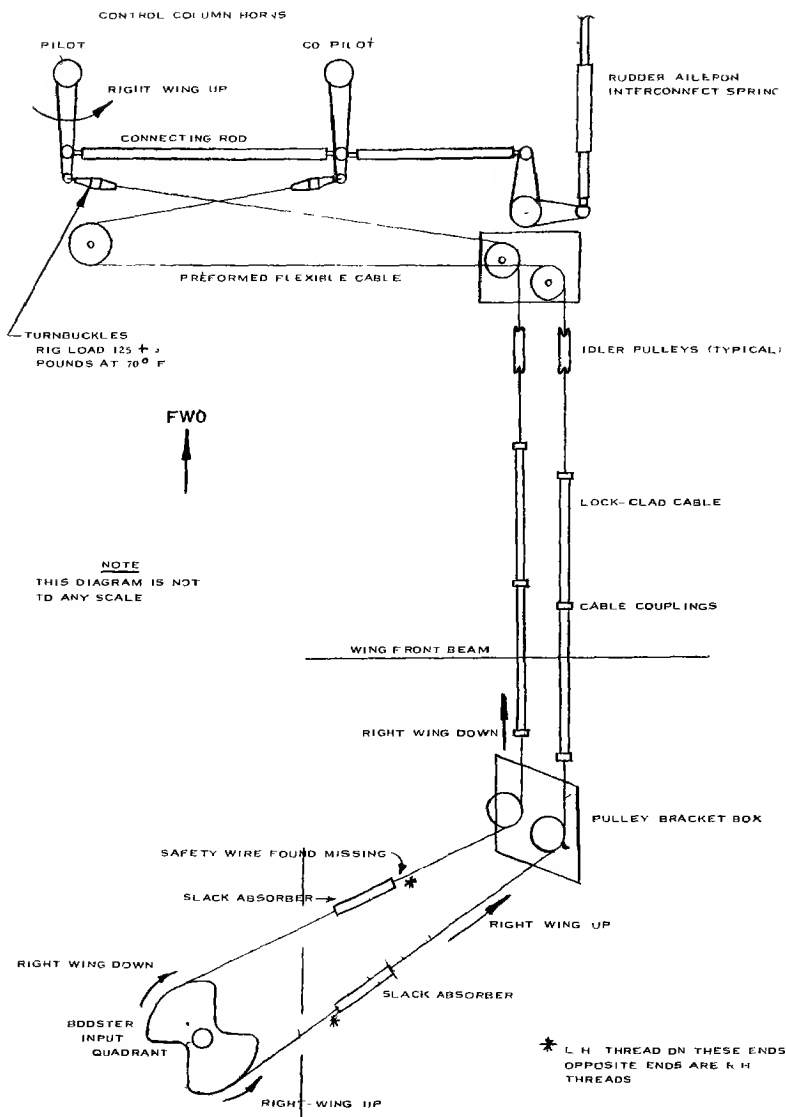
AILERON PRIMARY CONTROL SYSTEM

From the aileron boost unit's input quadrant to both control wheels, the aileron primary control system consists of two cables which run through a series of pulleys to the control wheels, forming a closed loop.^{3/} The cable which connects to the pilot's control horn is in tension for a right wing down control movement and the cable which connects to the copilot's control horn is in tension for a left wing down movement.^{4/} These cables provide a signal input from the control wheels to the boost unit when the boost is engaged, and they also provide the physical link between the control wheels and the ailerons for manual operation when the boost is disengaged.

The pilot's cable run starts with a 153.53-inch run of flexible cable routed athwartship to a pulley at Butt Line 34R, Water Line 128.5. From here, the cable consists of two consecutive 205-inch lengths of lockclad cables which run aft and down to a point just in front of a pulley bracket at Fuselage Station No. 651. A 39.25-inch flexible cable then joins the lockclad and passes through a 0.6-inch diameter guide hole in the front of the pulley bracket at Fuselage Station No. 651 and connects by a left-hand threaded stainless steel connector 4.2 inches long into the forward brass terminal block of a slack absorber unit. Proceeding from the aft brass terminal block of the slack absorber is a stainless steel, right-hand threaded connector attaching to a 42.01-inch length of flexible cable with a swaged ball fitting at the end which connects on the aileron boost input quadrant.

The copilot's cable is routed athwartship with a 200.34-inch length of flexible cable to a pulley at Butt Line 16.7L and then returned to the right side to a pulley at Butt Line 35R, Fuselage Station No. 127, and Water Line 132. From here aft, the run consists of lockclad cables identical with and parallel to the pilot's cable, and approximately an inch outboard. Just in front of the pulley bracket at Fuselage Station No. 651, a 43.75-inch flexible cable connects to the lockclad and passes through a 0.6-inch diameter guide hole in the front of the pulley bracket approximately one inch to the right and one-half inch below the pilot's flexible cable guide hole. After this, it joins a slack absorber unit with identical stainless steel fittings as on the pilot's side except that the forward one is right-hand threaded, and the rear, left-hand threaded. A 28.88-inch flexible cable with a swaged ball on the end connects the cable to the aileron boost input quadrant.

A previous description of the aileron primary control system showed that between the pilot's and copilot's control wheels and the aileron boost input quadrant, two cables run through a series of pulleys to the boost input quadrant, forming a closed loop; that the pilot's cable is in tension for a right wing down movement and the copilot's cable is in tension for a left wing down movement, and that these cables respond to movement of the control wheels either in the boost-engaged or the boost-disengaged condition. Furthermore, it has been established that if a disconnect or failure in either cable occurs, a loss in aileron control will result. It has also been shown that if a sudden disconnect or failure occurs in the copilot's cable, the rigging tension in the pilot's cable will displace the boost input quadrant, thereby imparting a signal to the aileron boost unit for a right wing down movement.
